Safe Coring and Drilling Areas Found Quickly, Efficiently

Accurate hand tool is easy to learn and use on reinforced concrete

BY LUKE M. SNELL AND YAGAANBUYANT DUINKHERJAV

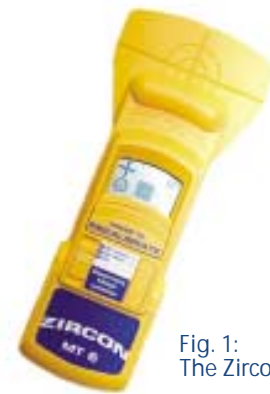
Fig. 1:
The Zircon MT6

to operate. Subsequent to this study, the company produced a new version costing less than \$200. In preliminary tests, the new locator, the Zircon MT6 (Fig. 1), performed even better than the 6.0 model.

The MT6 is relatively small at about 9 in. (230 mm) long, 3-3/4 in. (100 mm) wide, and 2-1/4 in. (60 mm) deep. The unit weighs about 10 oz. (290 g). It requires a 9-volt alkaline battery. The manufacturer's literature states that the unit's operative temperatures are 20 to 120 °F

(-7 to 49 °C) and that it can locate steel to an embedment of 6 in. (150 mm) within a ±1 in. (25 mm) accuracy.

Zircon Corp. posts on its website (www.zircon.com) step-by-step instructions for the use of the MT6. After turning the device on, a technician holds the instrument in an area of concrete that does not contain steel. After pushing its recalibration switch at this location, the technician then moves on to scan the concrete surface. It will give a beeping sound when it is directly over steel, and the depth of the steel is displayed on the built-in screen.

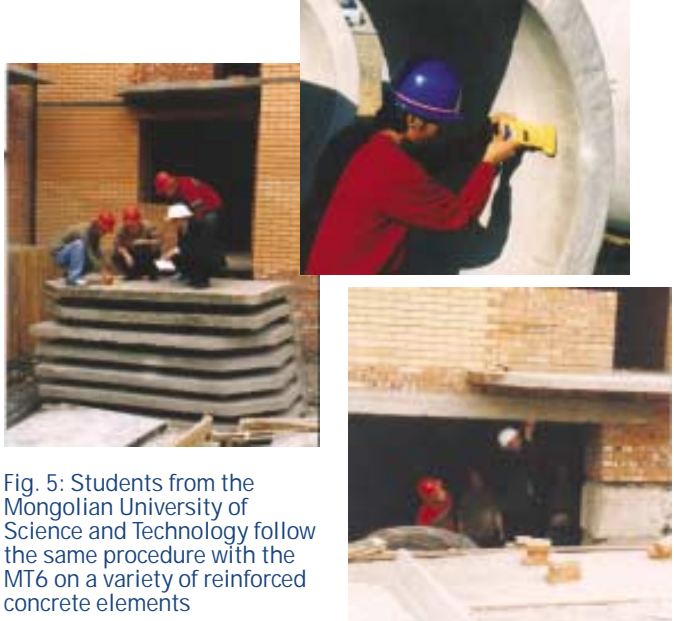
Fig. 5: Students from the Mongolian University of Science and Technology follow the same procedure with the MT6 on a variety of reinforced concrete elements

Mongolian students followed the same procedures. They, too, were able to locate steel reinforcement in precast concrete pipe and slabs and on a construction project as shown in Fig. 5.
